# TDT Plumbing

## Pipe Restoration

**SANTA CRUZ POST OFFICE**  
Santa Cruz, CA

Drain Line Restoration

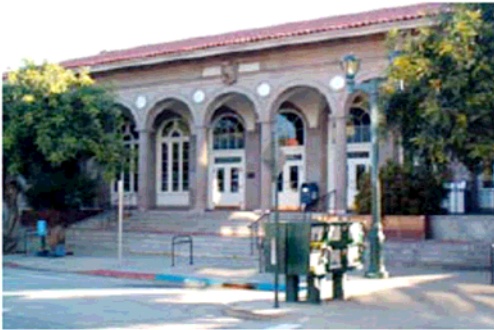
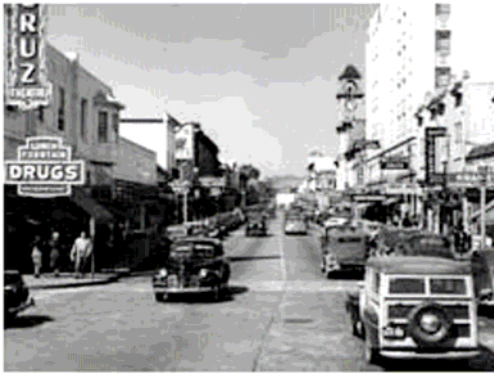
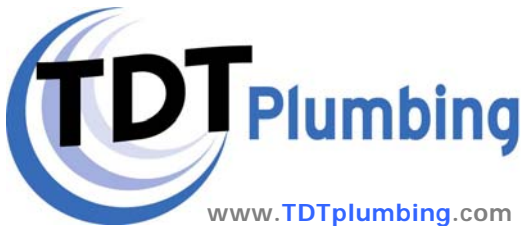
The challenge facing the National Park Service, who administer the well being of the historic Santa Cruz Post Office, was a failing main roof drain line and how to fix it without destroying the architectural importance of this historical building. The challenges of the job involved restoring a drain system that had bends and multiple 90 degree elbows. An attempt using inversion-lining techniques by a company that specializes in inversion lining had failed. During the attempted installation, the inversion liner split at the seams and could not be navigated through the elbows.

*ACE DuraFlo® – Drain Lining System.* The National Park Service, still determined to find a fix to the main roof drain line, had heard about the ACE DuraFlo® drain lining system and placed a call to ACE DuraFlo®'s Bay Area Pipe Restoration in San Francisco. Unlike inversion lining systems, the ACE DuraFlo® drain lining system is capable of being installed in drain systems with elbows and bends. In what became a full-day job, ACE DuraFlo® successfully restored the main roof drain line of this historically significant building.
